Situation Ein- und Ausfahrt  
M 1: 250

Minimaler Platzbedarf für Anlieferung mit Sattelschlepper L=16.50 - Situation Zufahrt  
M 1: 250

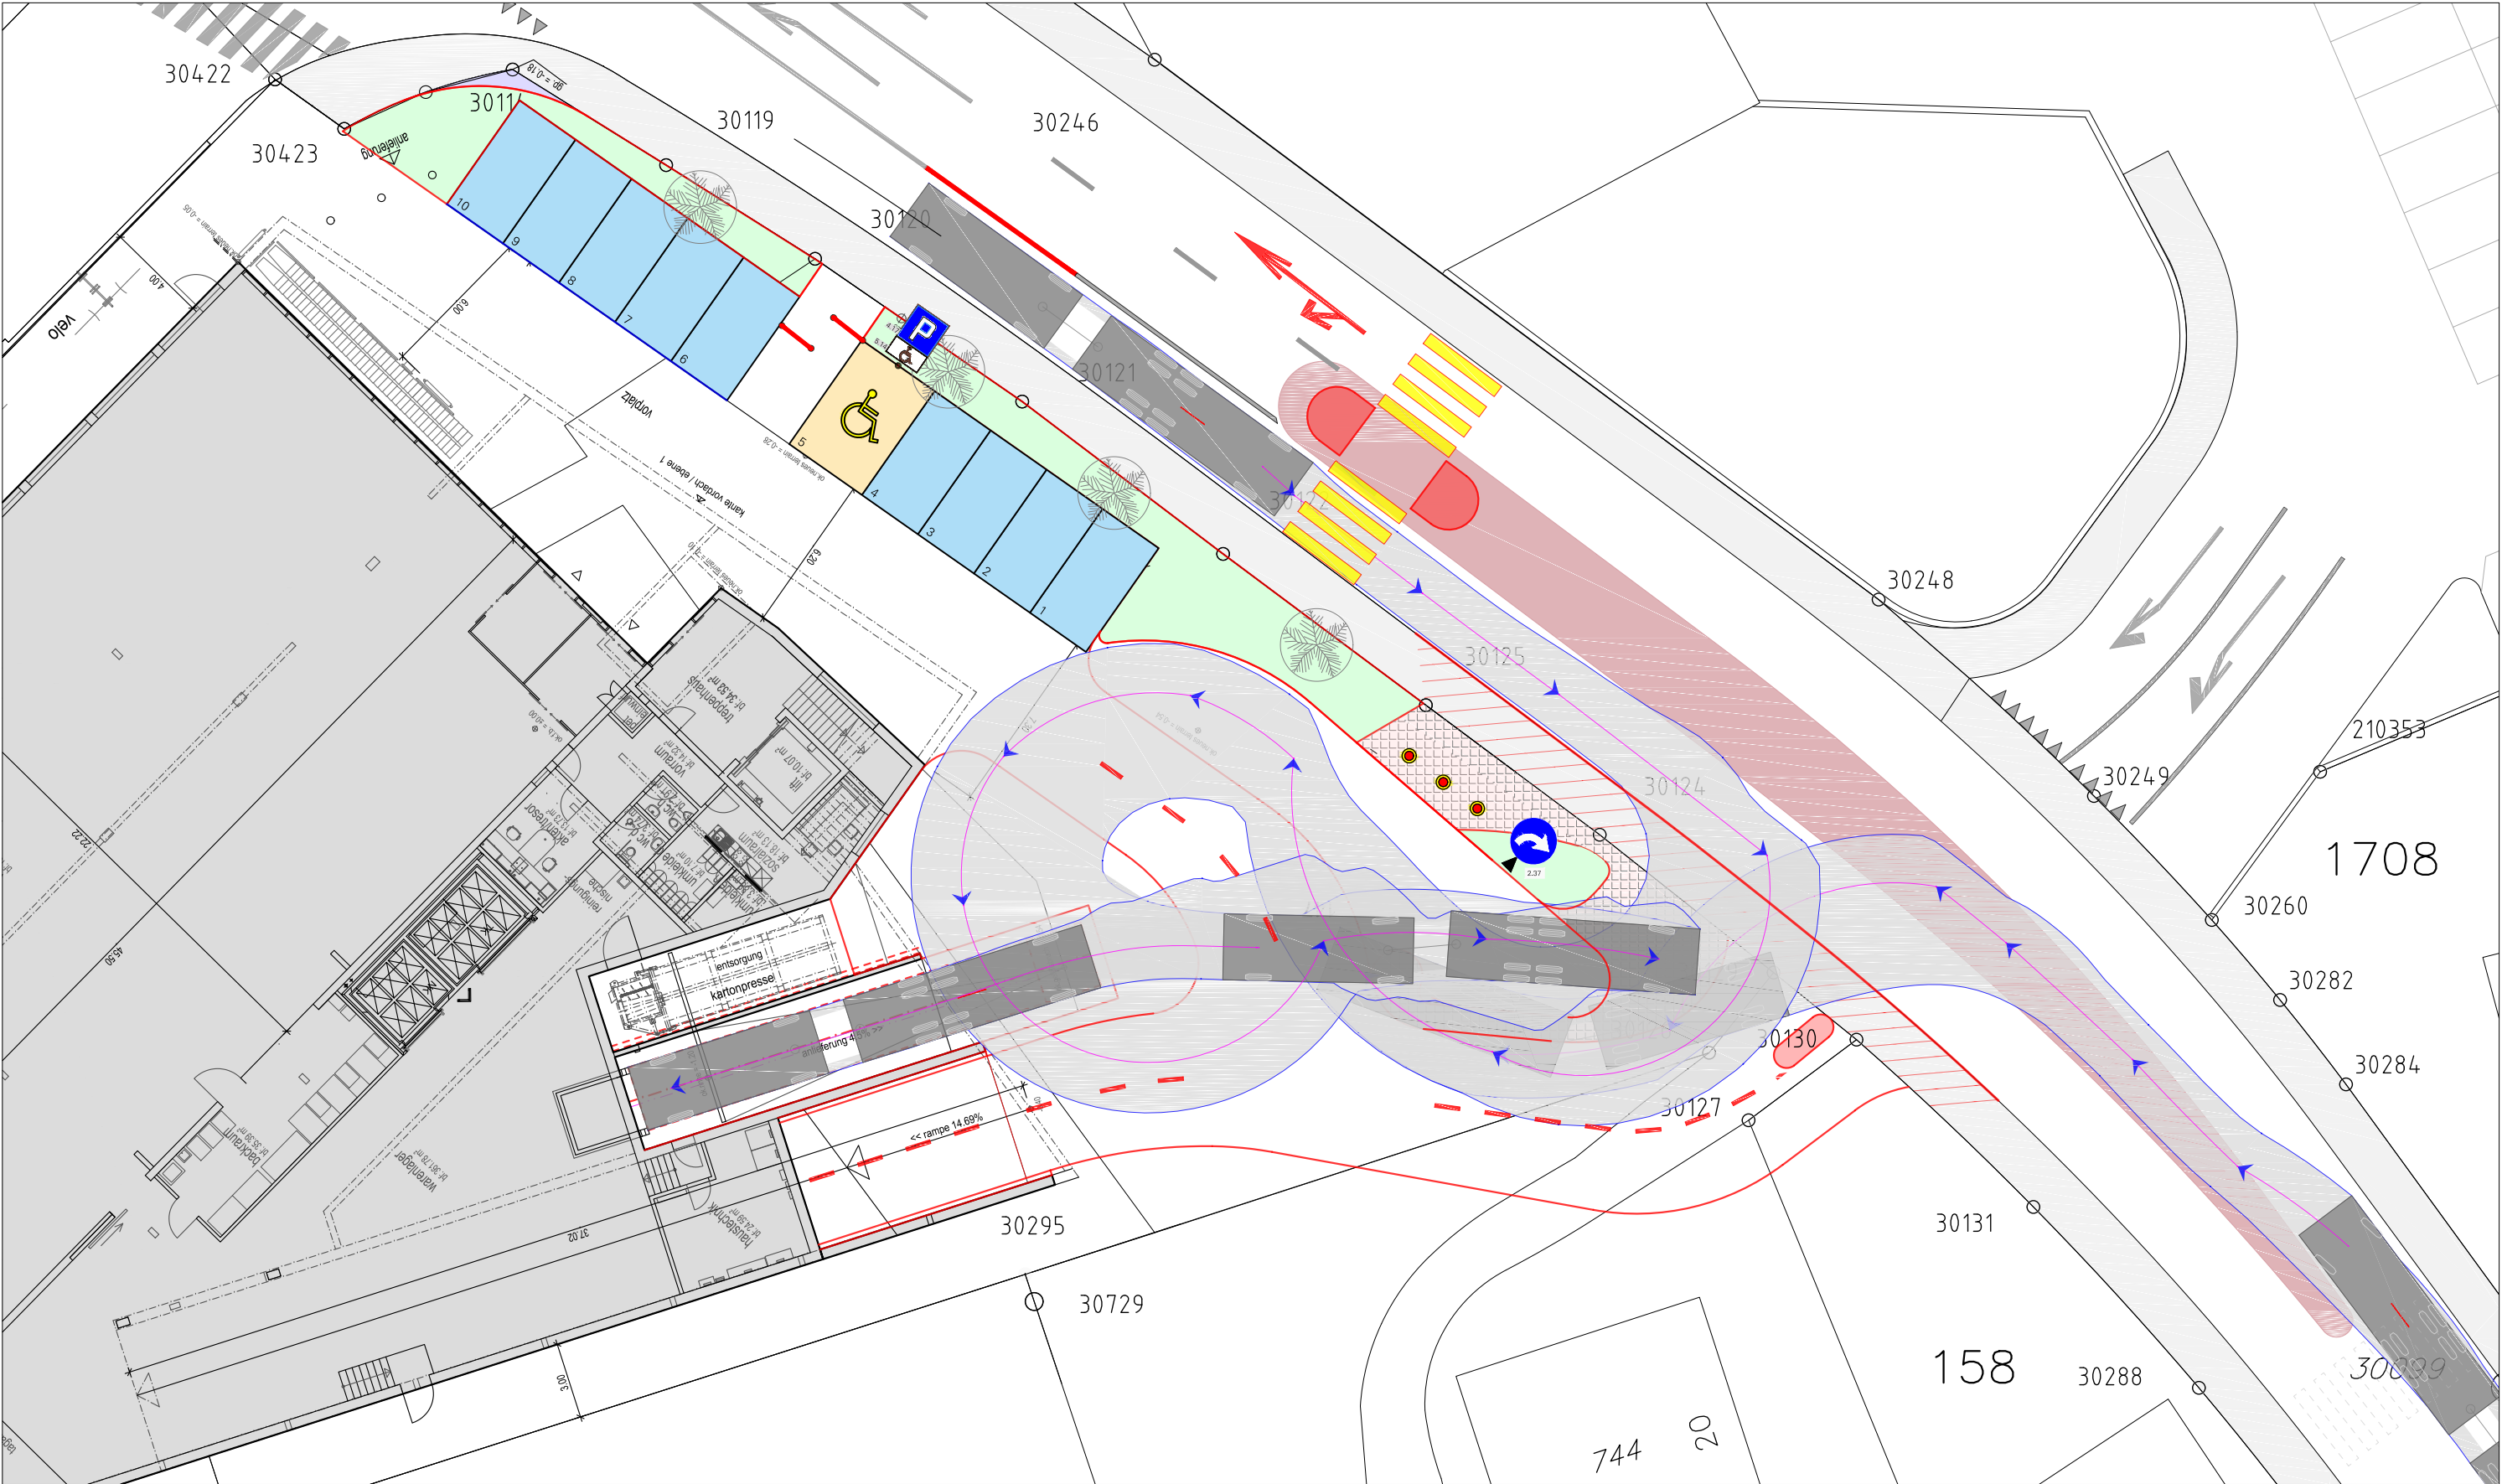
Minimaler Platzbedarf für Anlieferung mit Lastwagen mit Anhänger L=18.75 - Situation Zufahrt  
M 1: 250

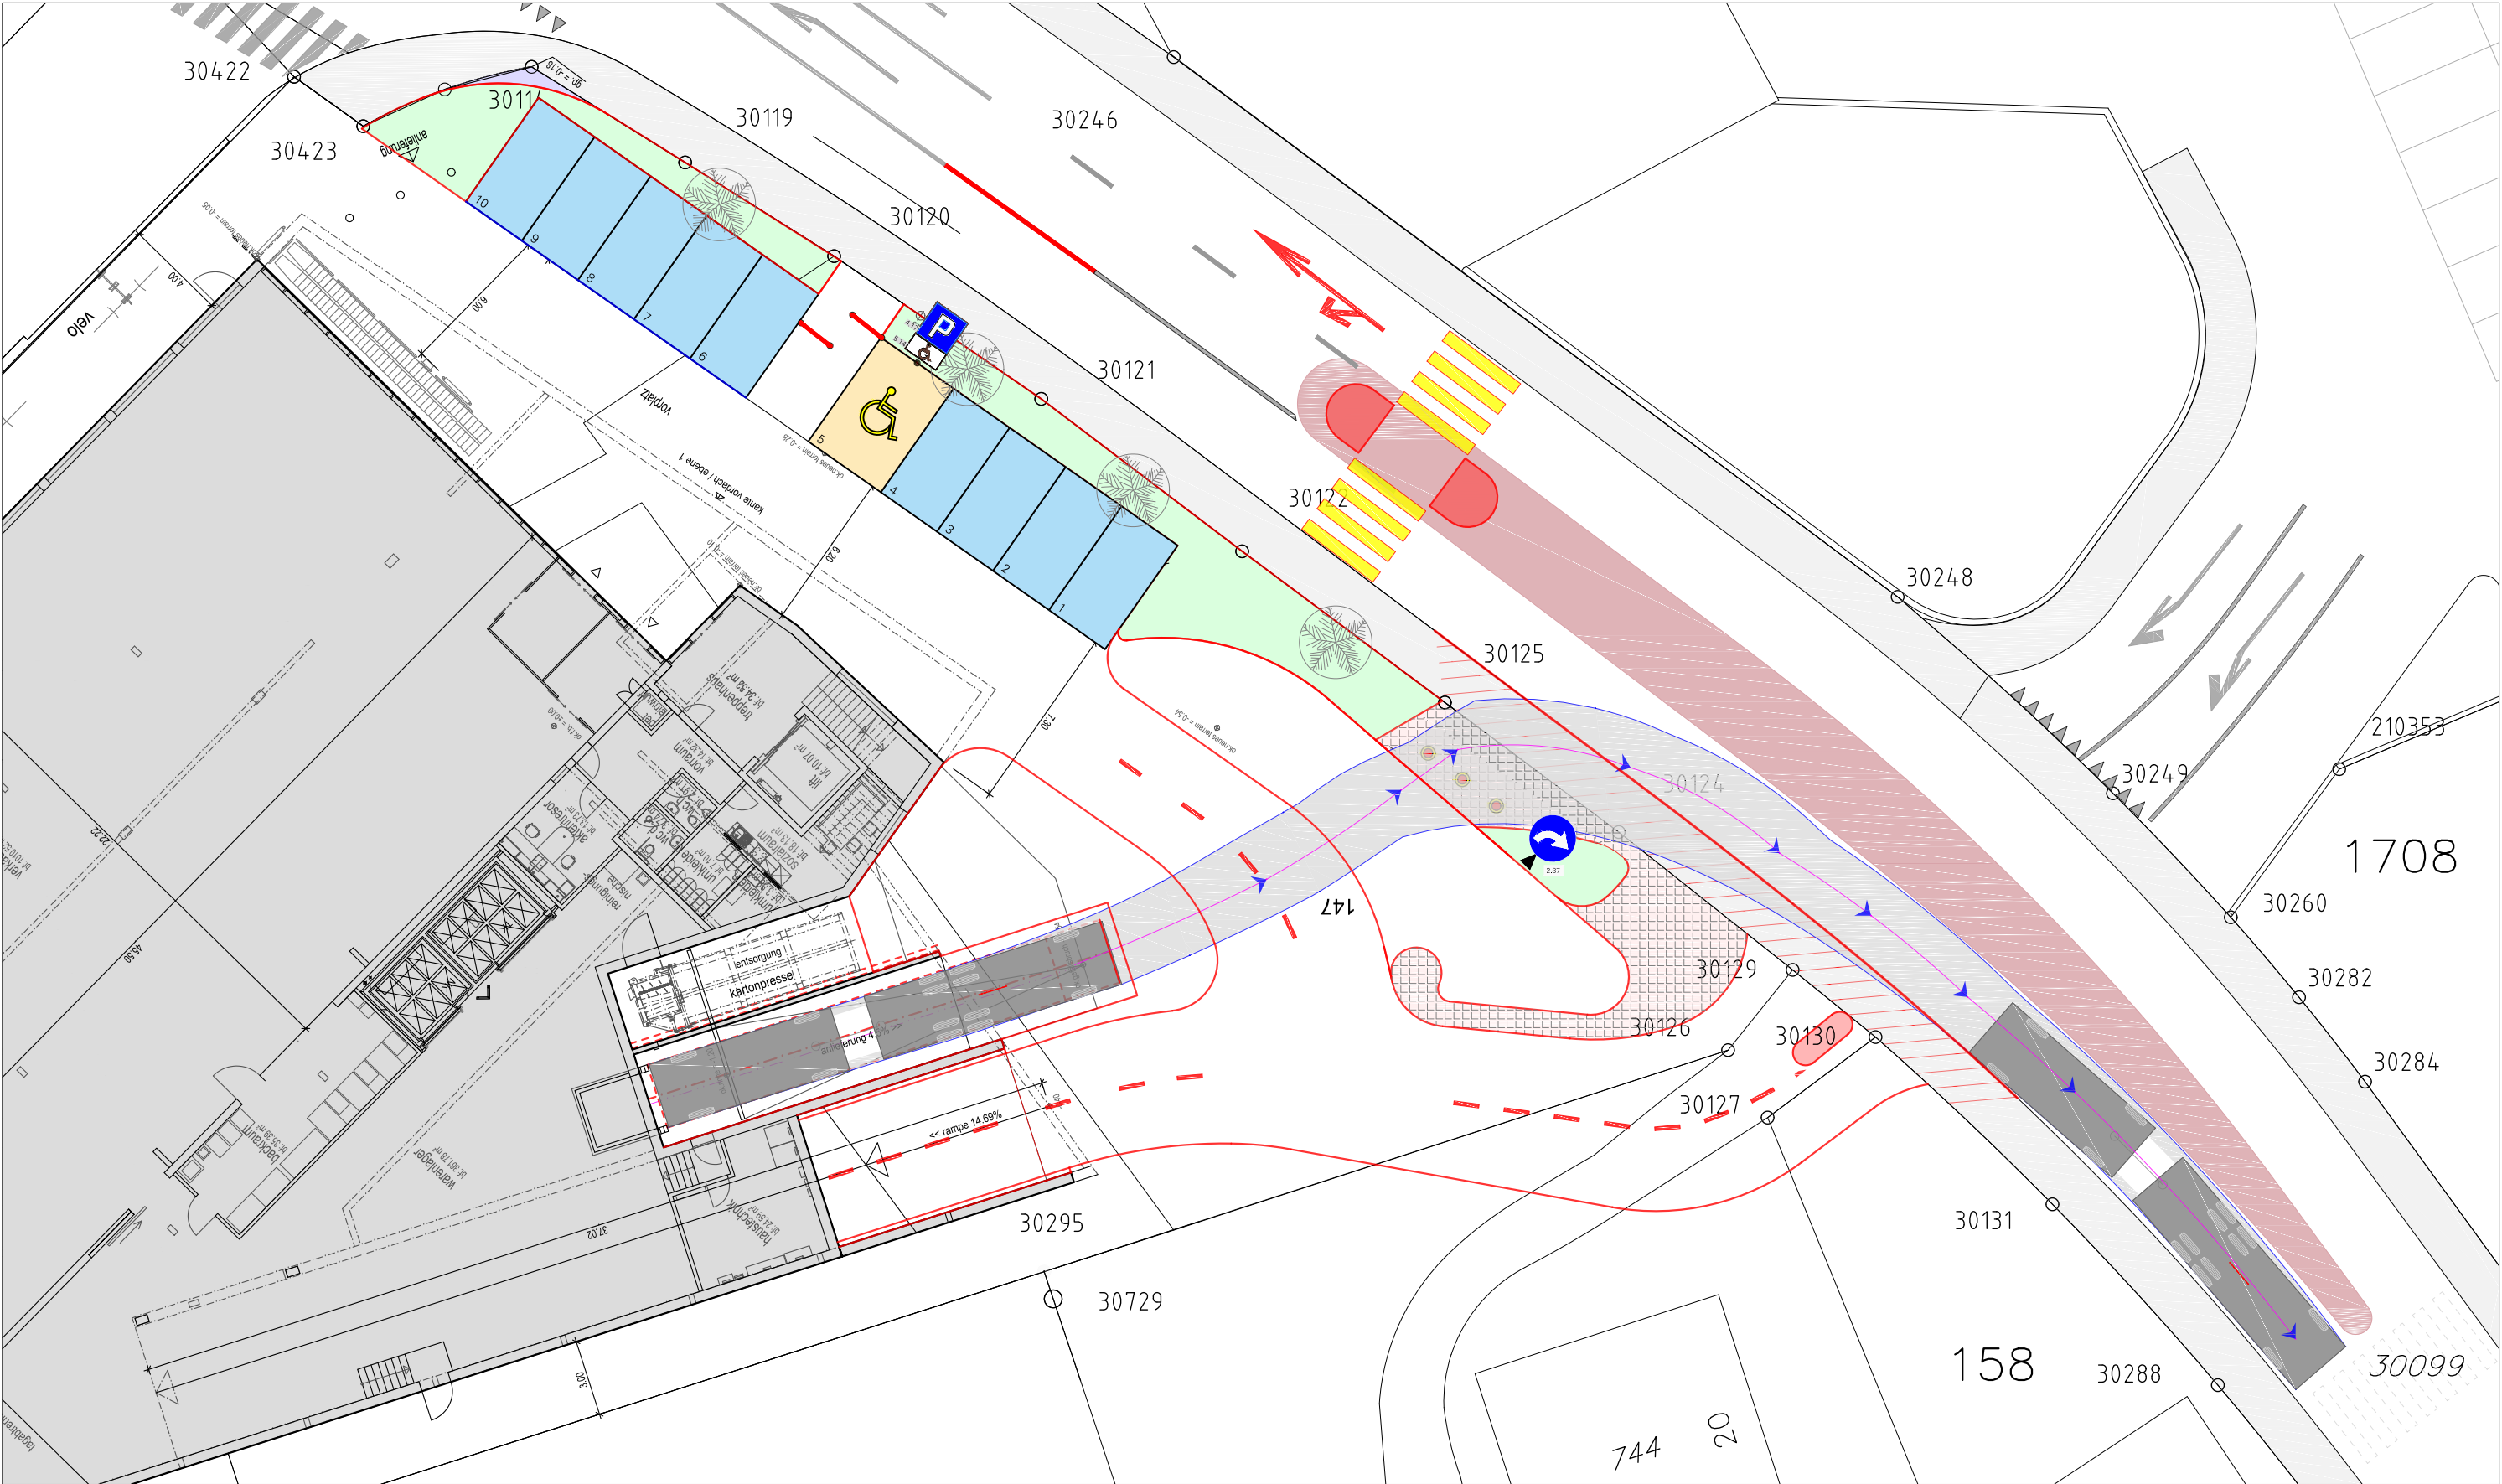
Minimaler Platzbedarf für Anlieferung mit Lastwagen mit Anhänger L=18.75 - Situation Wegfahrt (nur nach Rechts möglich)  
M 1: 250

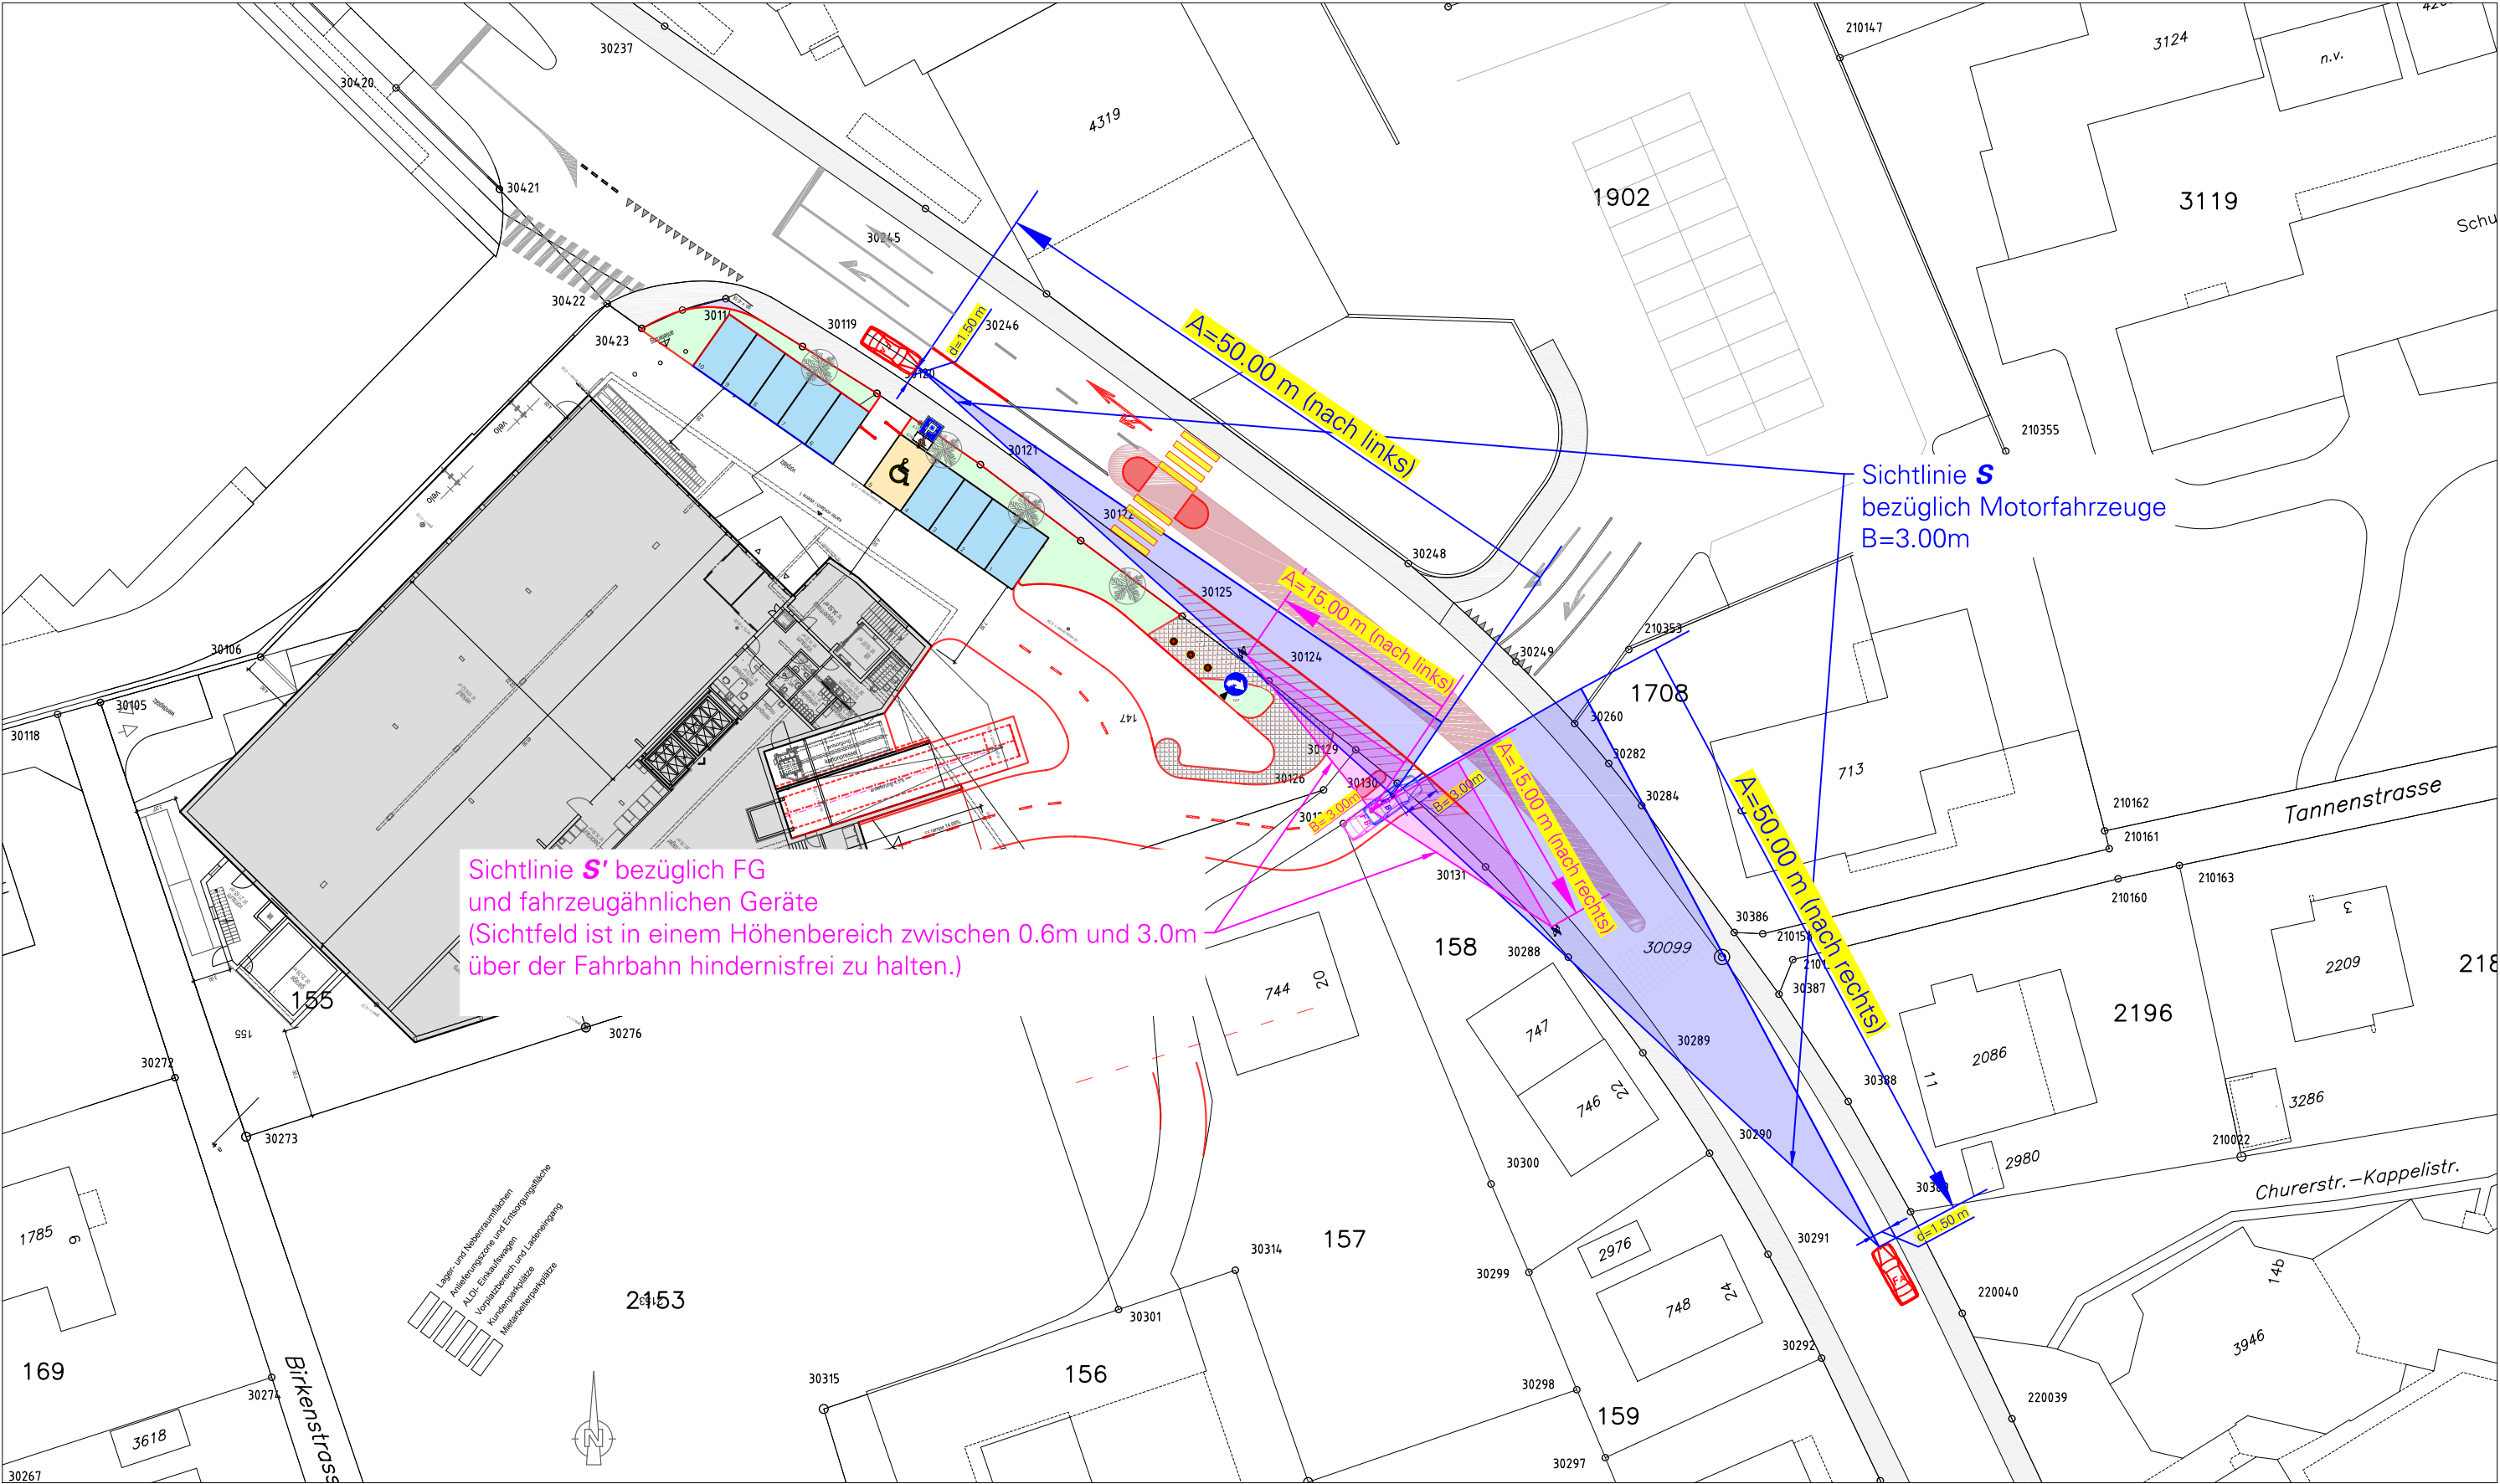
Erforderliche Sichtbedingungen gemäss SN 640 273a

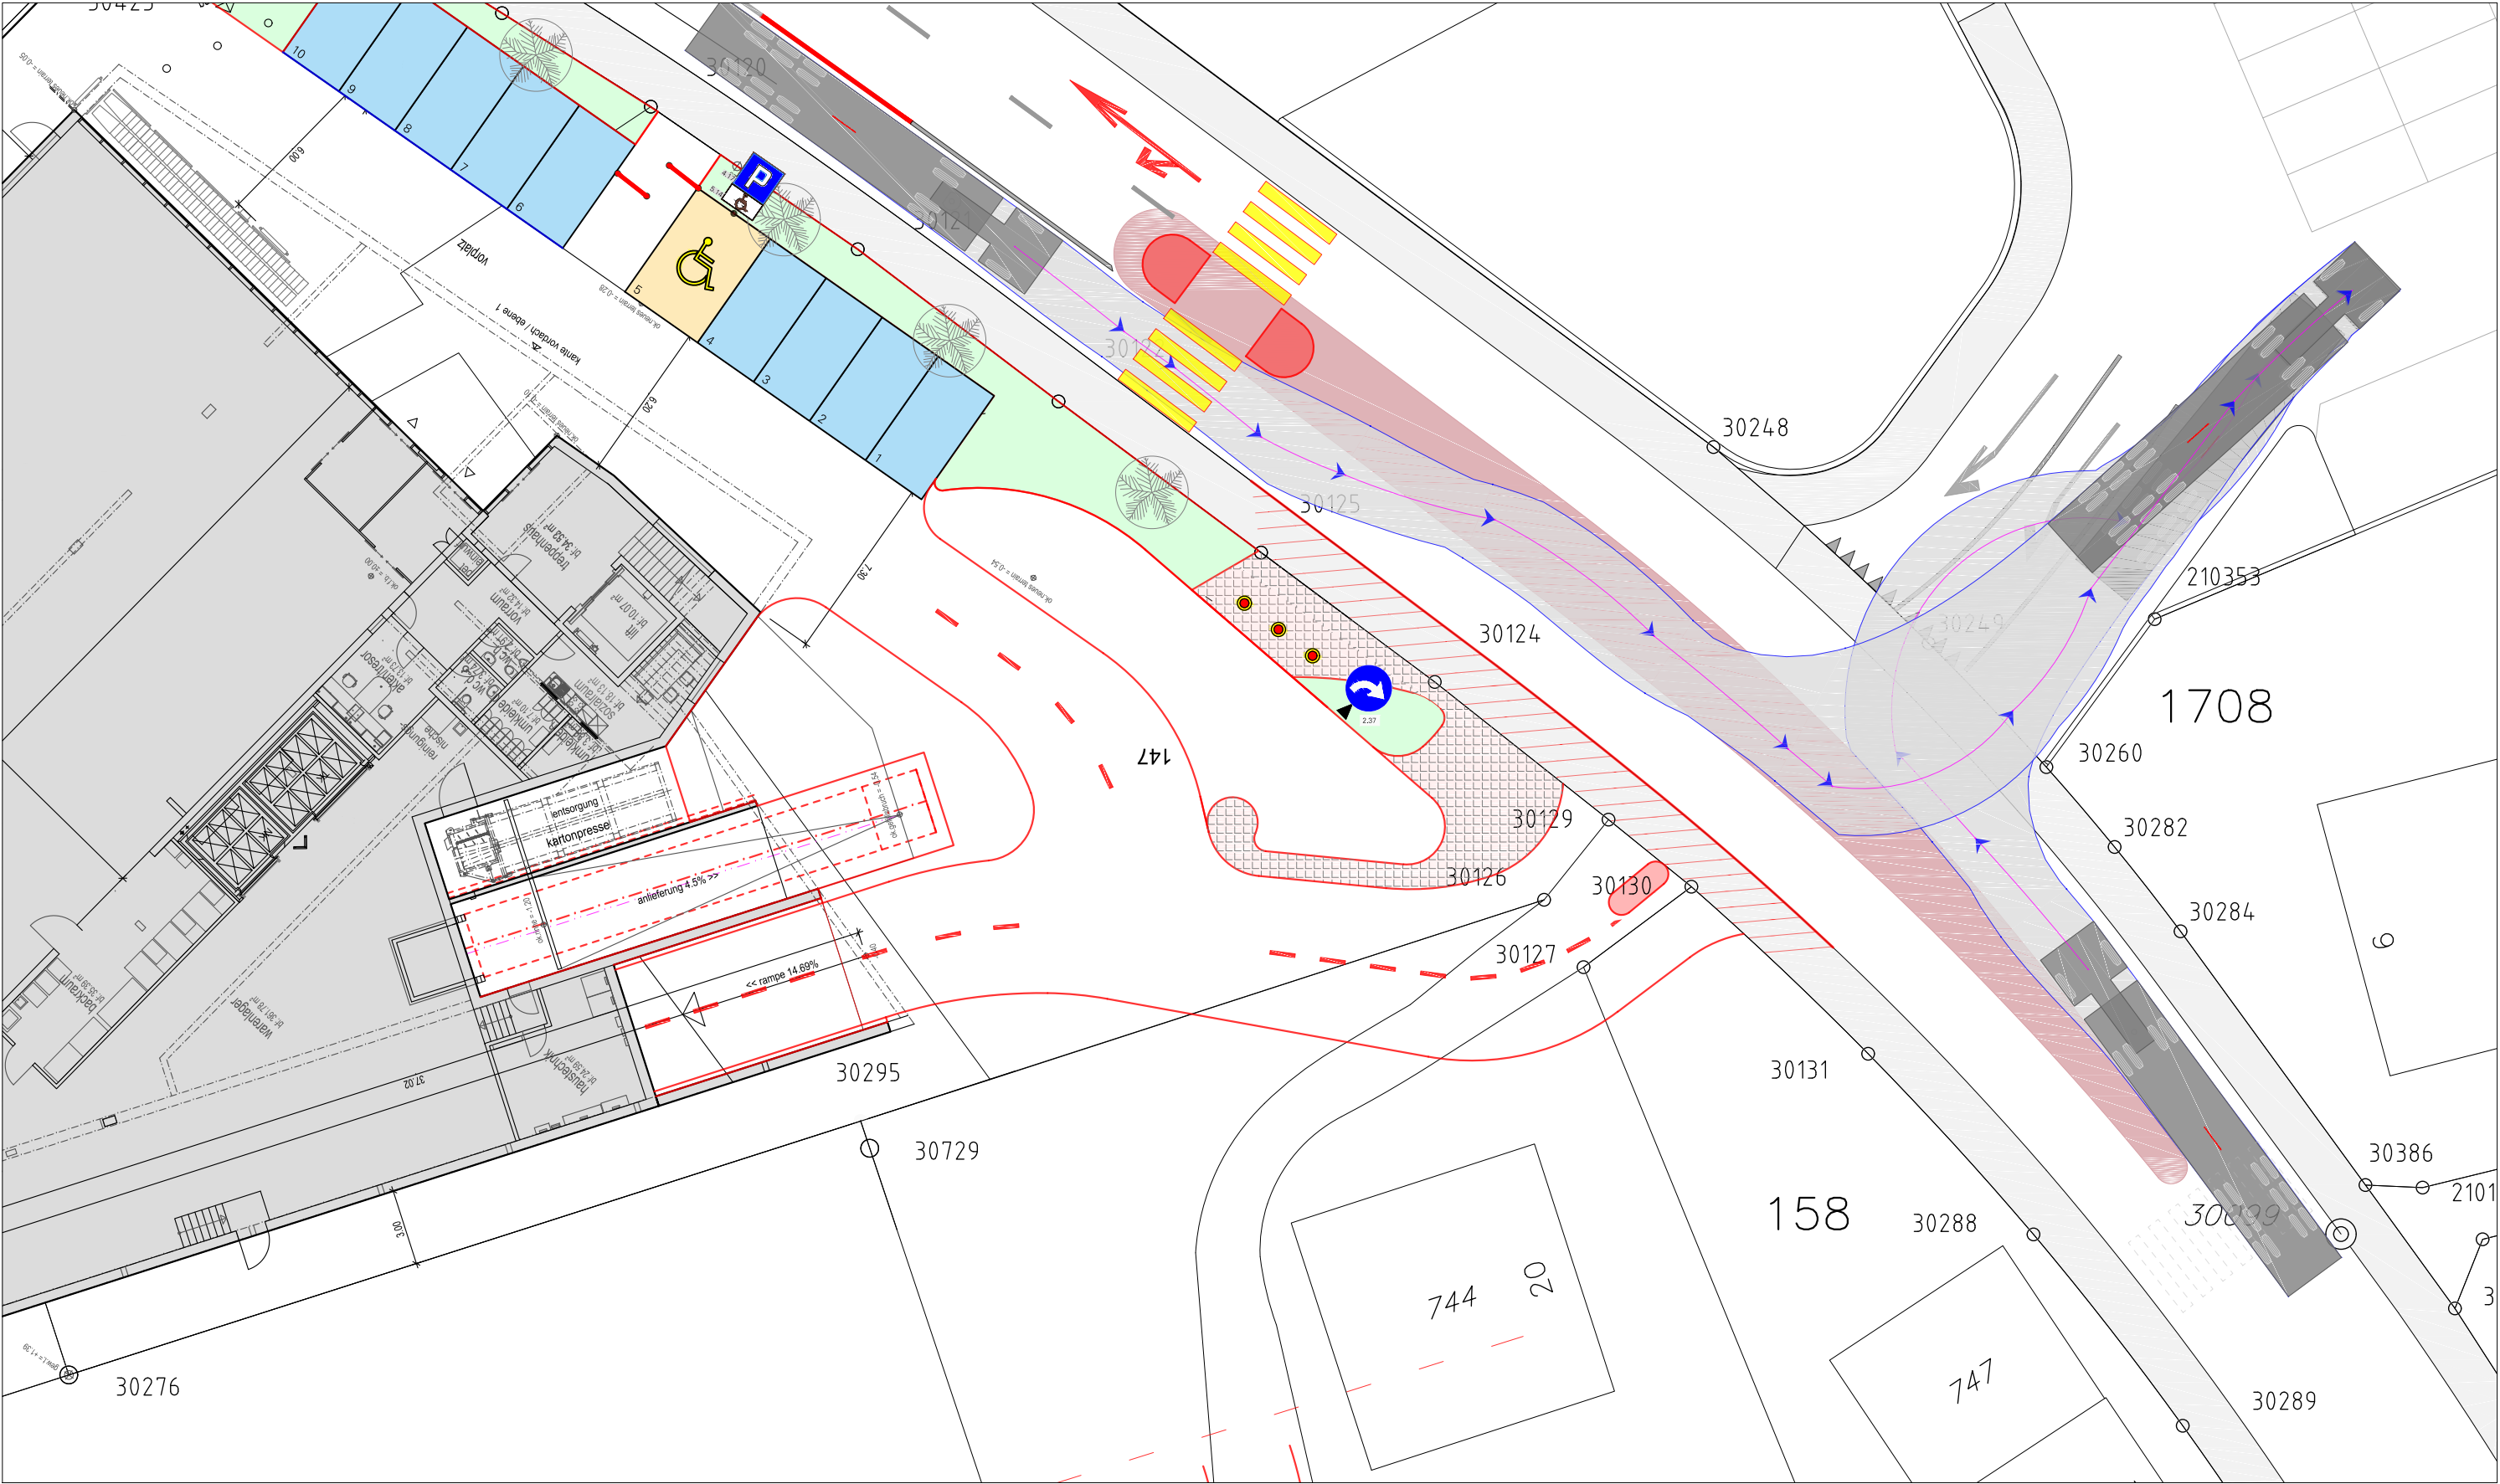
Überprüfen der Befahrbarkeit am Knoten Ein- Ausfahrt Migros Areal mit Sattelschlepper L=16.50m - Situation Zufahrt  
M 1: 250
